DEPARTMENT OF TRANSPORTATION

Contract #: 04-0120F4Cty: SF/ALA Rte: 80 PM: 13.2/13.9File #: 69.28**WELDING INSPECTION REPORT****Resident Engineer:**Siegenthaler, Peter**Address:** 333 Burma Road**City:** Oakland, CA 94607**Report No:** WIR-020464**Date Inspected:** 09-Feb-2011**Project Name:** SAS Superstructure**OSM Arrival Time:** 700**Prime Contractor:** American Bridge/Fluor Enterprises, a JV**OSM Departure Time:** 1900**Contractor:** Zhenhua Port Machinery Company, Ltd (ZPMC), Changxing Island **Location:** Shanghai, China**CWI Name:** Qiu Wen**CWI Present:** Yes No**Inspected CWI report:** Yes No N/A**Rod Oven in Use:** Yes No N/A**Electrode to specification:** Yes No N/A**Weld Procedures Followed:** Yes No N/A**Qualified Welders:** Yes No N/A**Verified Joint Fit-up:** Yes No N/A**Approved Drawings:** Yes No N/A**Approved WPS:** Yes No N/A**Delayed / Cancelled:** Yes No N/A**Bridge No:** 34-0006**Component:** OBG**Summary of Items Observed:**

WELDING INSPECTION REPORT

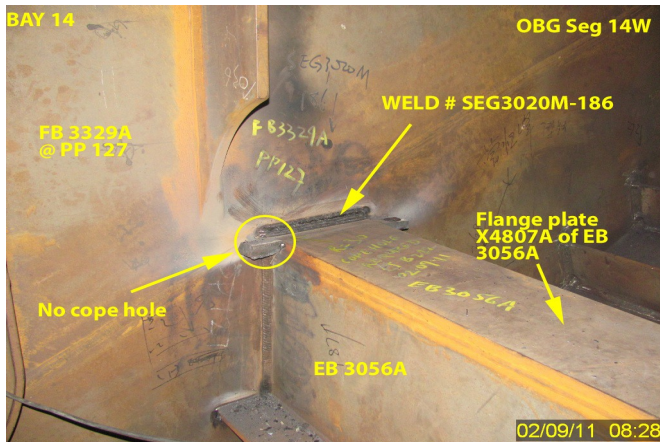
During random in process inspection this QA inspector observed that the Edge Beam (EB) 3056A welded with Floor Beam (FB) 3329A at Panel Point (PP) 127. The weld number is identified as SEG3020M-186. As per shop drawing, the flange plate X 4807A of EB3056A required cope hole with radius of 30mm but on field installed flange plate does not have any cope hole. This issue has been discussed with ZPMC CWI Mr. Qiu Wen and CT lead QA. Mr. Qiu Wen informed this QA that this issue would be corrected in manner compliant with contract document. Attached photograph provide additional details.
